**Inspection Report**

**Mine Name:** ITM

**Operator Name:** Lexco

**Permit number:** S0470035

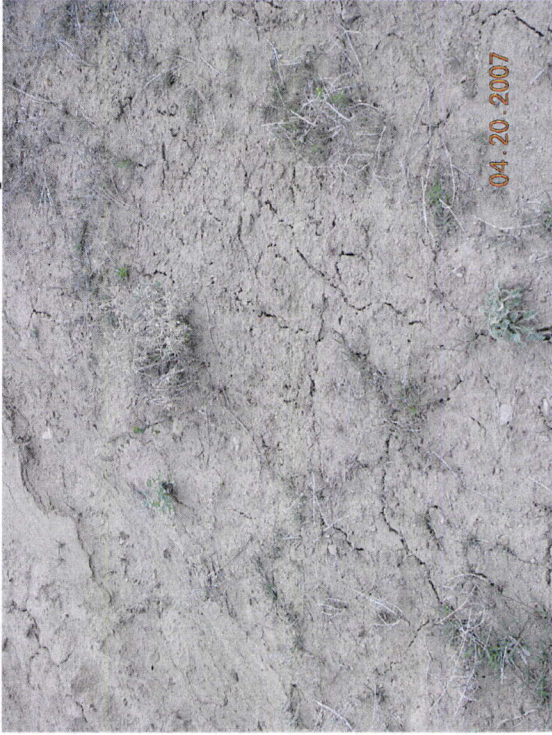
The access road has a moderate amount of desirable vegetation, especially grasses with some fourwing saltbush and globemallow, but there is also a lot of cheatgrass. The mine area has even less desirable vegetation.

Photo 1. A closeup of vegetation on the reclaimed road.

While I did not measure vegetation cover, the site would not meet the criteria for release. If Lexco decides it no longer wants to mine in this area, I recommend that the area be reseeded. If the site will probably be re-disturbed, it would not make sense to reseed.

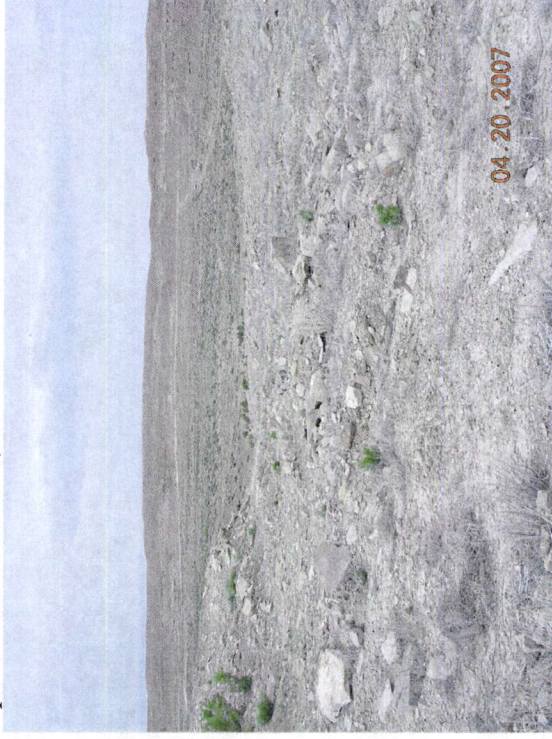
Photo 3. A view of a portion of the mine area.

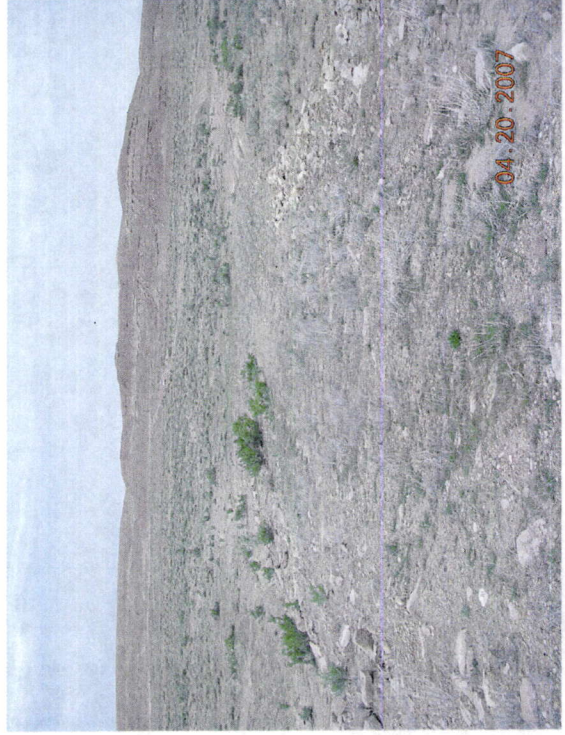
Photo 2. Overview of the reclaimed access road and some of the surrounding area.

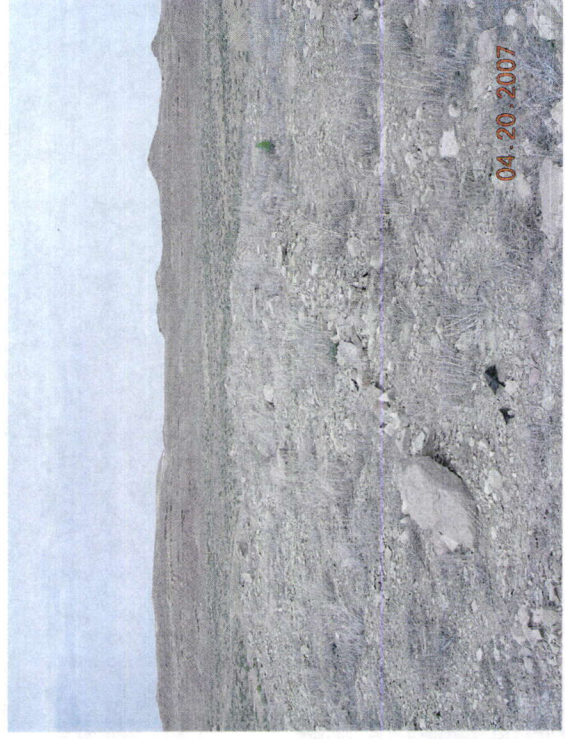
The mine was reclaimed in a year when there was little rain and snow, and although the operator used good roughening techniques, it is not surprising how little vegetation has become established.

Photo 4. Another view of the mine area. Note how little perennial vegetation is present.
